# Kent Road and Northumberland Road Protected Bike Lanes, Pascoe Vale

Road Safety Audit

Audit Stage: Concept Design

Report for Moreland City Council

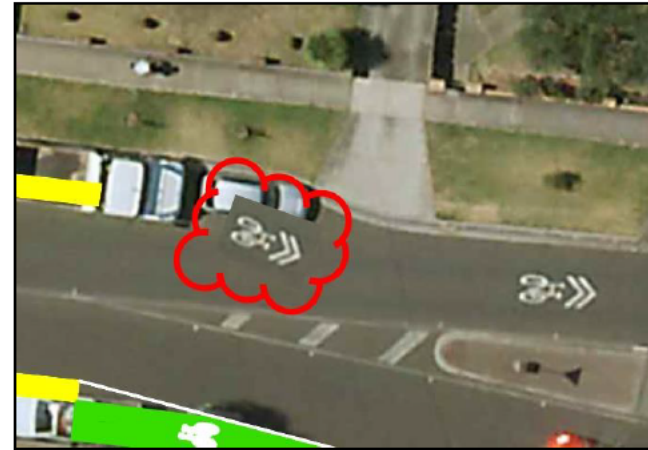
| Audit Findings | Level of Risk | Safe System Energy | Recommendations<br><br>P – Primary<br>S – Supporting<br>ST – Step Towards<br>N – Non-Safe System | Responsible Officer | |
|---|---|---|---|---|---|
| <div><div>i. Eastbound cyclists on approach to the Cumberland Road roundabout are forced to merge from the protected bike lane into the traffic lane. This creates a conflict point between vehicles and cyclists. The proposed layout may confuse road users as it is not clear who gives way to who (do cyclists have priority when merging or do vehicles in the traffic lane have priority?)</div><div></div><div>This finding also applies where the protected bike lane terminates on approach to Cornwall Road.</div></div> | <div>Improbable</div> <div>Minor</div> <div>LOW</div> | <div>Within tolerable limits*</div> | <div>Consider installing a sharrow pavement marking at this location to raise motorists' awareness that cyclists are merging. (S)</div> <div></div> <div>*The Safe System Energy has been recorded as "within tolerable limits" as vehicles would likely be slowing as they approach the roundabout. It is expected that vehicle speeds would be at or below 30km/h (the Safe System speed for vulnerable road user crash types).</div> | | |

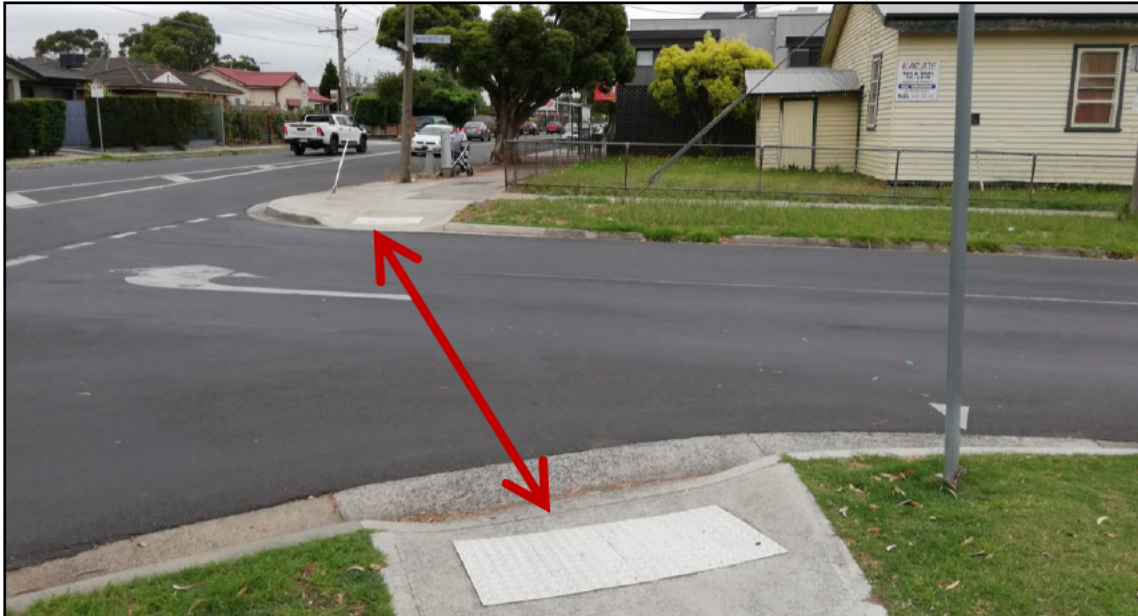
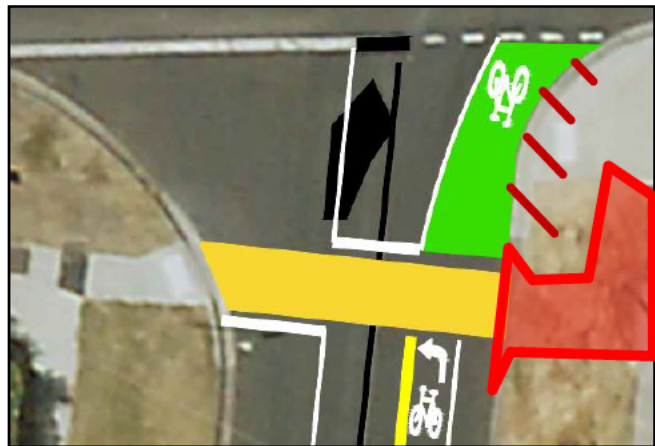
| Audit Findings | Level of Risk | Safe System Energy | Recommendations<br><br>P – Primary<br>S – Supporting      ST – Step Towards<br>N – Non-Safe System | Responsible Officer | |
|---|---|---|---|---|---|
| <div><div>i.      The kerb ramps on Northumberland Road near the Rhodes Parade intersection are staggered. Pedestrians would be required to cross at an angle (shown with arrows). This is not the most direct (shortest) path for pedestrians to take and increases their time on the carriageway, thus increasing the risk of pedestrian and vehicle collisions.</div><div></div></div> | <div>Improbable</div> <div>Minor</div> <div>LOW</div> | <div>Within tolerable limits</div> | <div>Consider shifting the kerb ramp further south to match up with the proposed coloured pavement. (S)</div> <div>It is noted that there is a utility pole support cable installed in this area, which may affect the relocation of the kerb ramp.</div> <div></div> | | |
